MATERIALS TEST REPORT

Ref. D249307 Date March 2, 2016 Page 1 of 5

Shear [ ] Part: GoClips STD
Load [X]
Impact [ ] Specifications: ATS 978 Rev.0 'Load Testing'
Density [ ]
Bend [ ]
Pressure [ ]

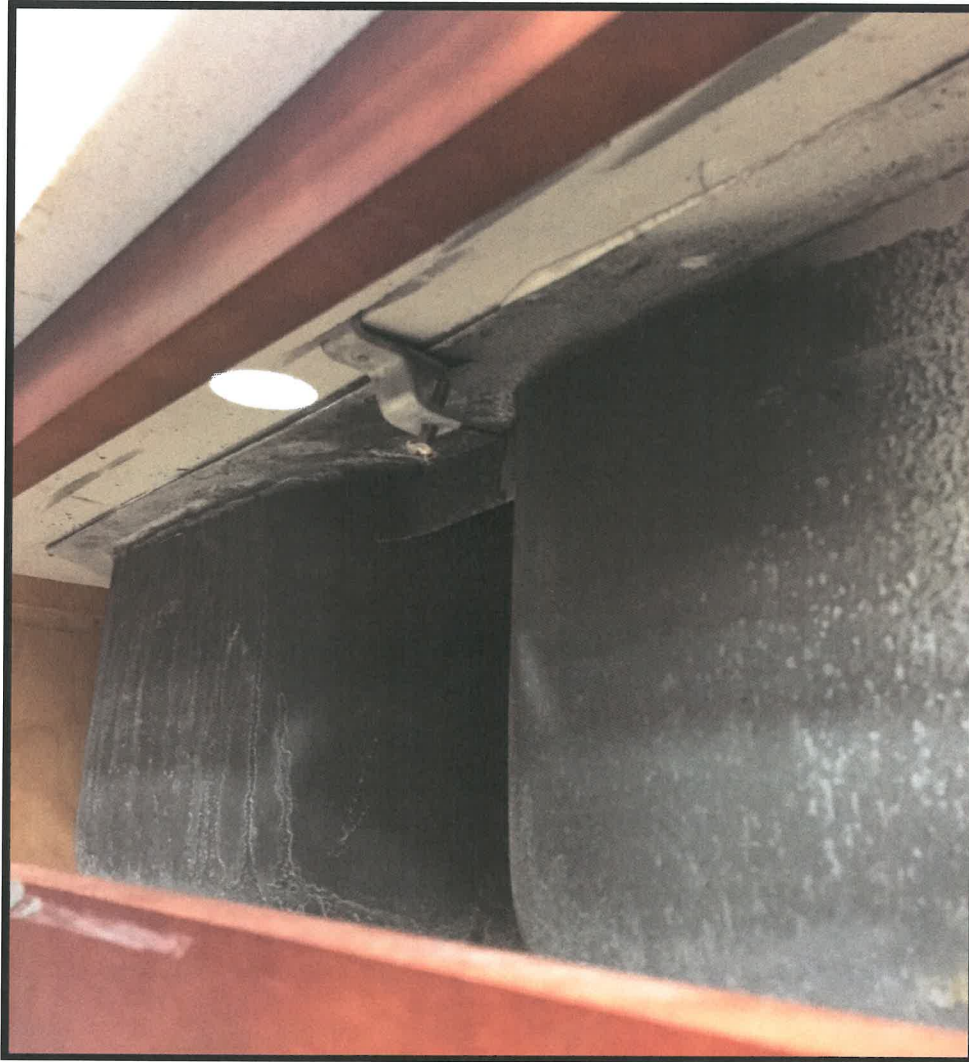
**Figure 2:** Example of GoClip installed under the countertop

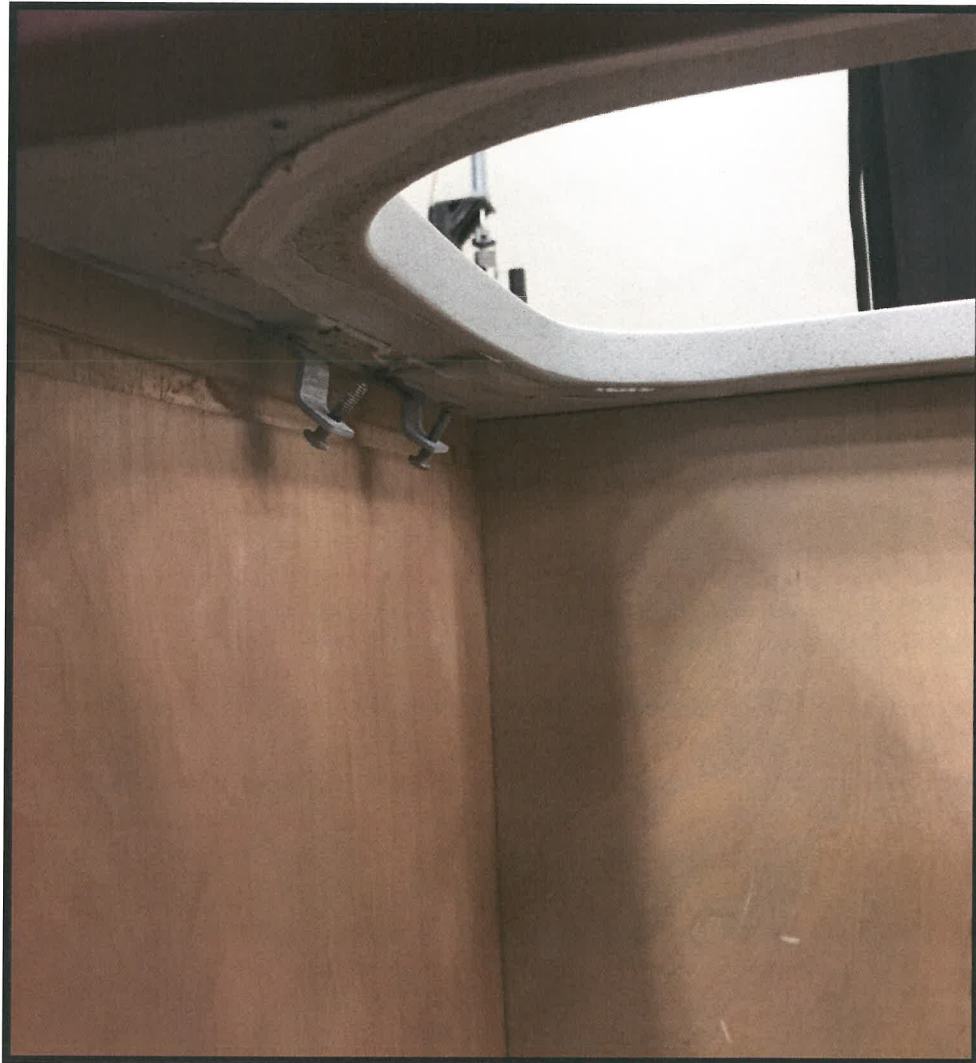
**Figure 3: GoClips after failure**

Table with 3 columns: Part Identification, Max Load (lbs), Remarks. Row 1: Sink/Countertop Assembly with GoClips, 1,247, Load test was performed on a customer supplied sink and countertop assembly. The sink was supported by 6 GoClips underneath the countertop. Distributed load was applied to the top of the sink until failure occurred in the clips causing the sink to fall. Maximum load was recorded. See figure 1-3 for test setup and results.
